Exhibit 57

Public Utilities Commission

CITATION

Enclosure 2 – PG&E Moss Landing Tower Collapse Direct Cause Analysis

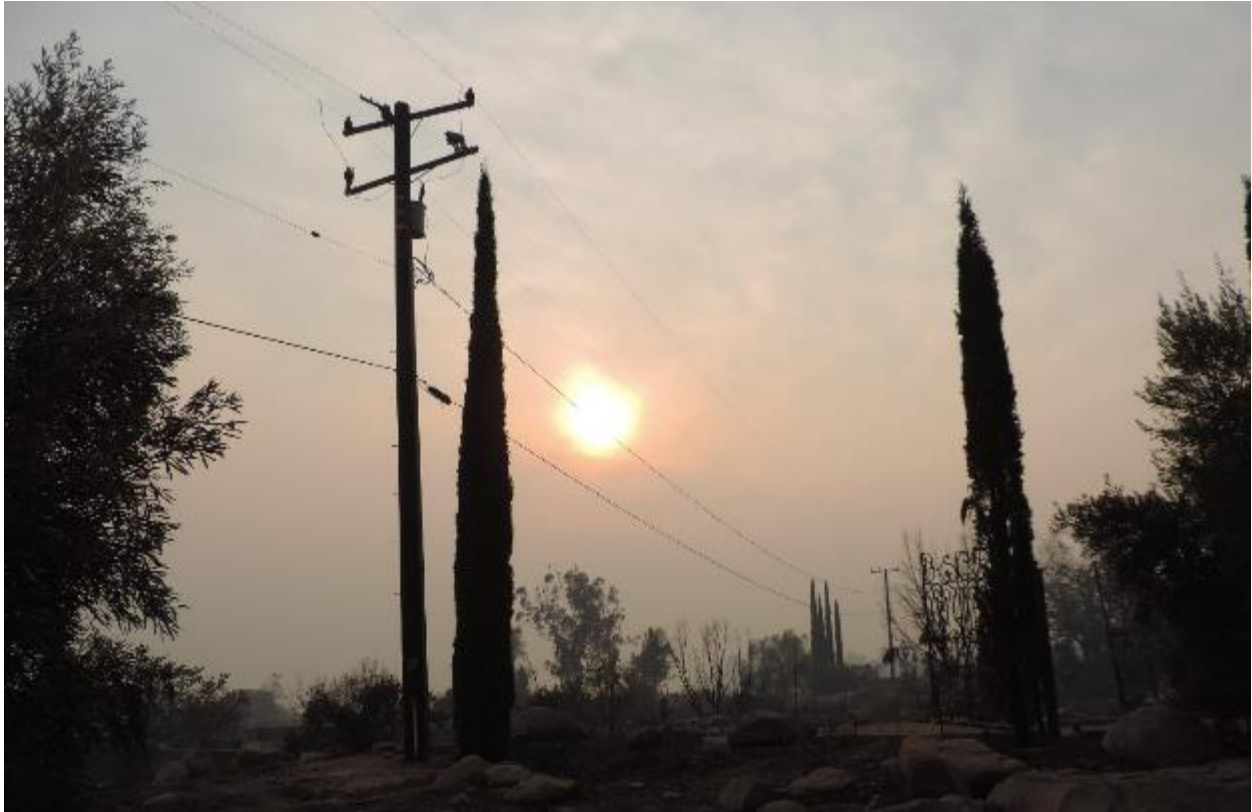
Site photos depict the Koenigstein ignition site, pole 729566E, and pole 729565E. The primary conductor failed towards the 729566E side of the span and remained attached on the 729565E side.

Figure 2: SED photo Koenigstein site, 729566E at the fore, 729565E at the rear.

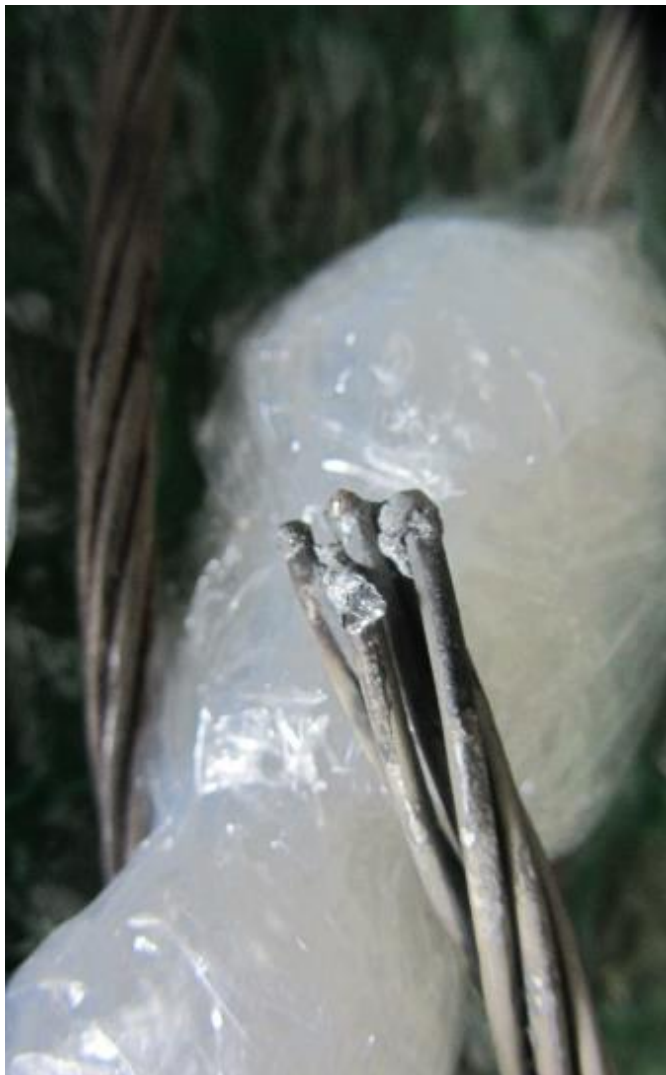
Figure 4: SED photo of Koenigstein evidence, one end of failed conductor.

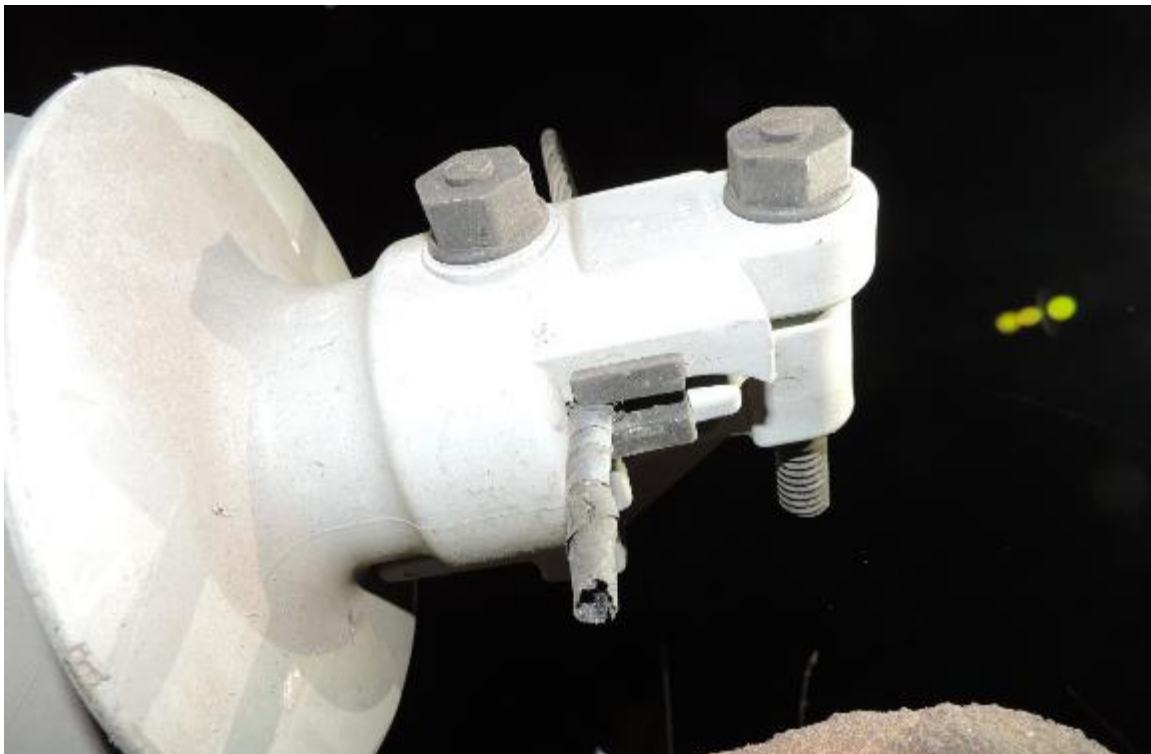
Figure 5: SED photo of Koenigstein evidence, other end of failed conductor (covered with electrical tape) still attached in the vise of the insulator mounted to 729566E

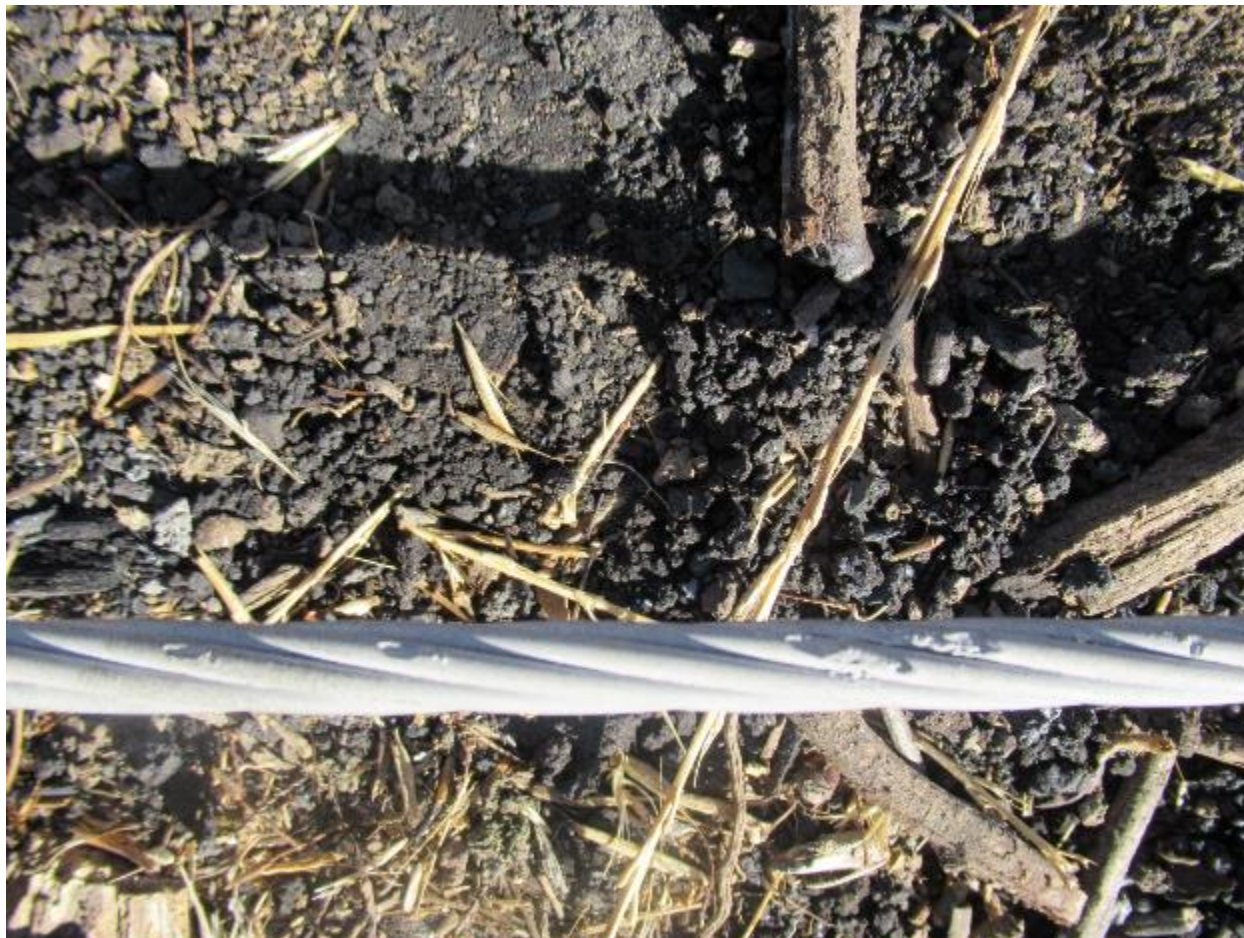
Figure 10: SED photo of Anlauf Canyon site, pitting on the east conductor between poles numbered 3002114E and 1202085E.

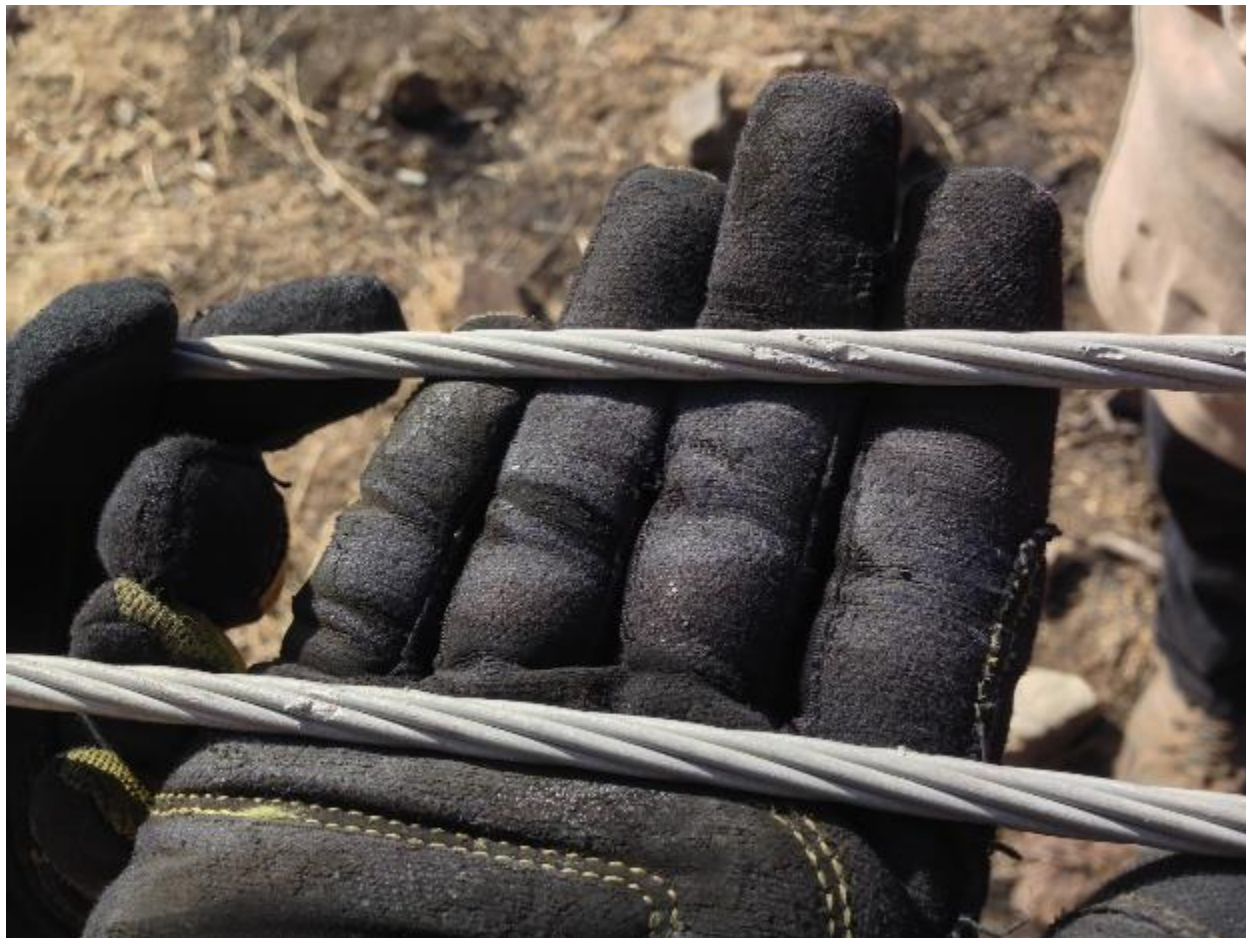
Figure 11: Edison photograph depicting damage on two unidentified adjacent conductors between poles numbered 1025341E and 3002114E.⁶²

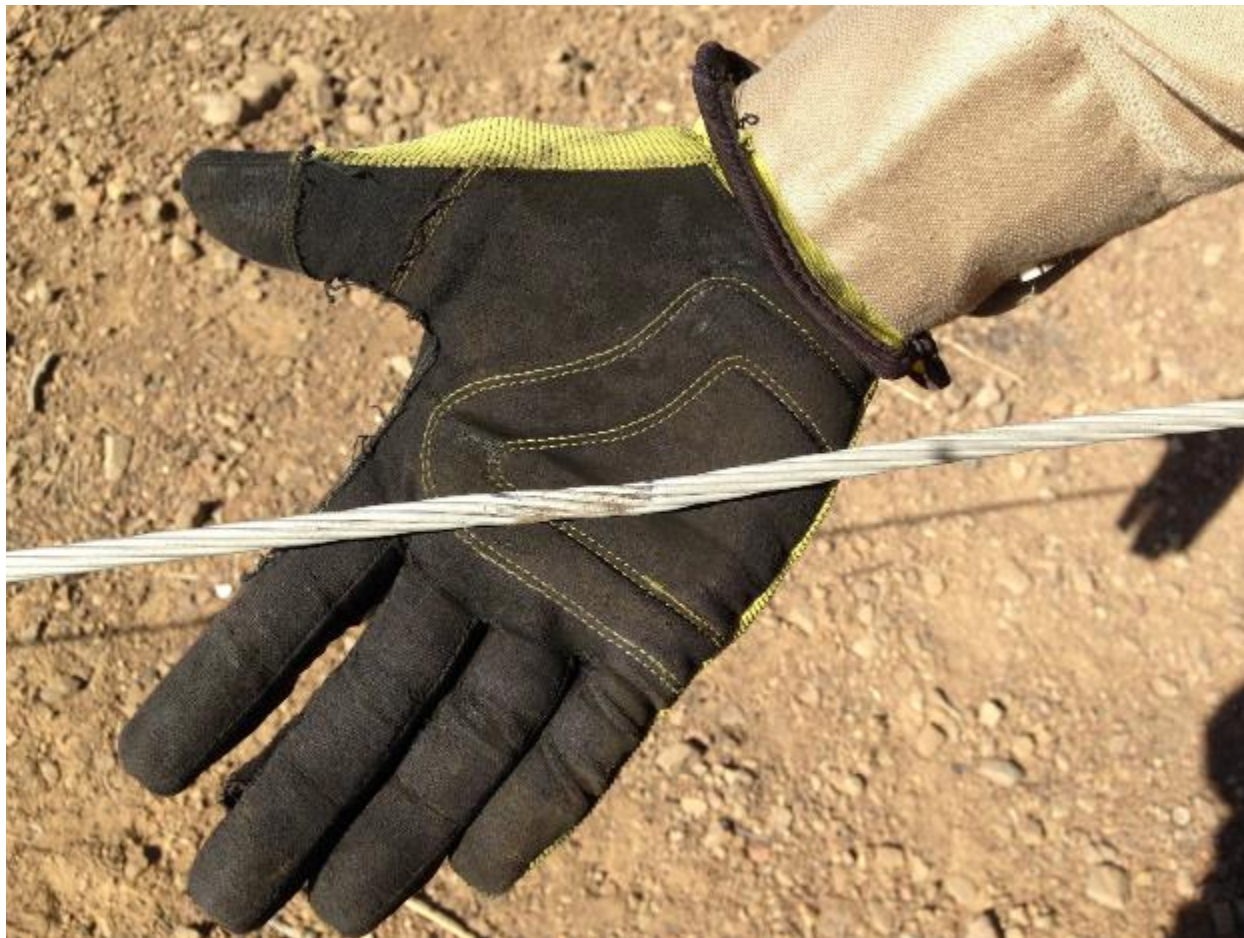
Figure 12: Edison photograph depicting damage on the center conductor between poles numbered 1025341E and 1202085E.⁶³

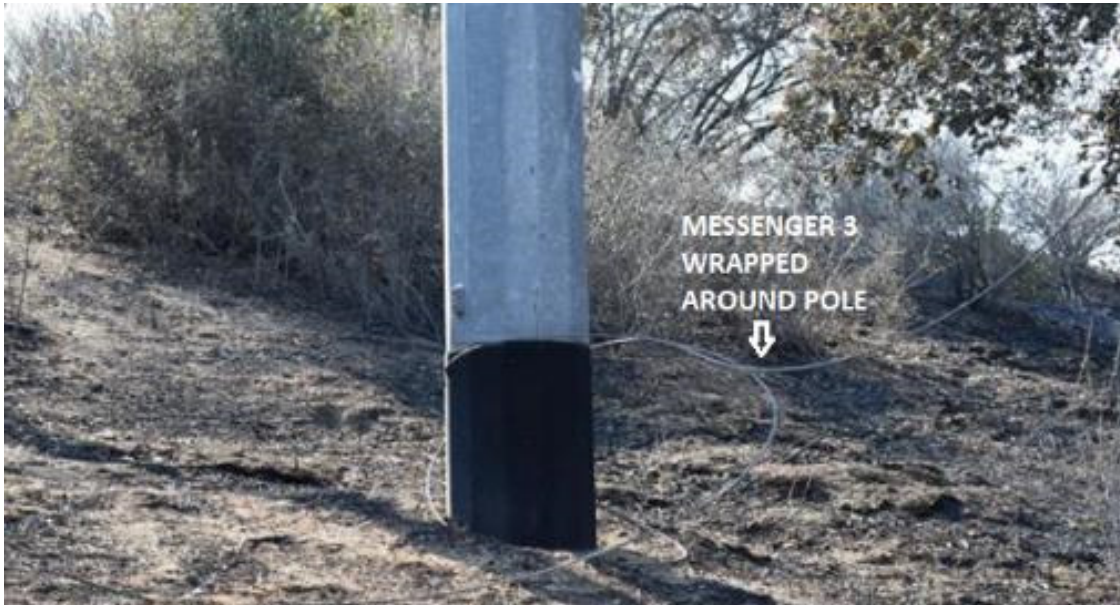
of the broken messenger wire was lying on the ground between the Steel Pole and a pole to the north. The northern pole had a pole tag marking it as pole number 1258776E, however Edison's records designate the pole as number 1528776E.

Figure 3: Messenger Wire 3 broken and wrapped around the base of the Steel Pole.⁷

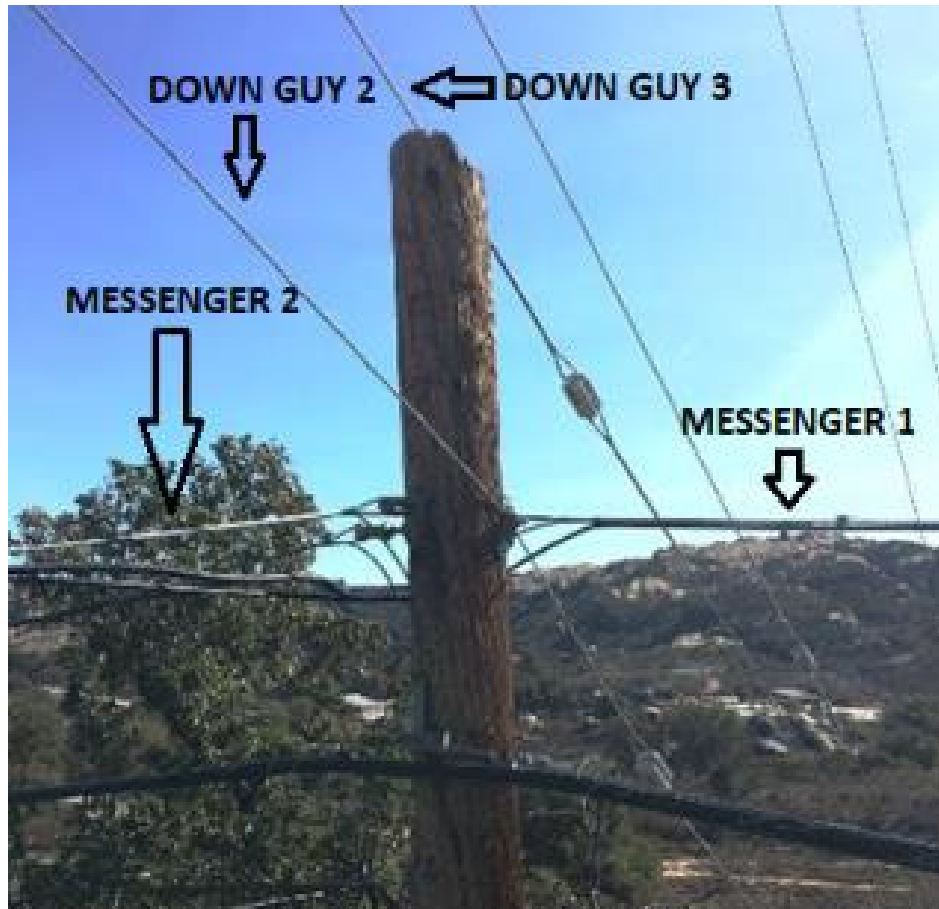
Figure 5: The Stubbed Pole as viewed from the northwest. Note the loose down guy in contact with Messenger Wire 1.⁸

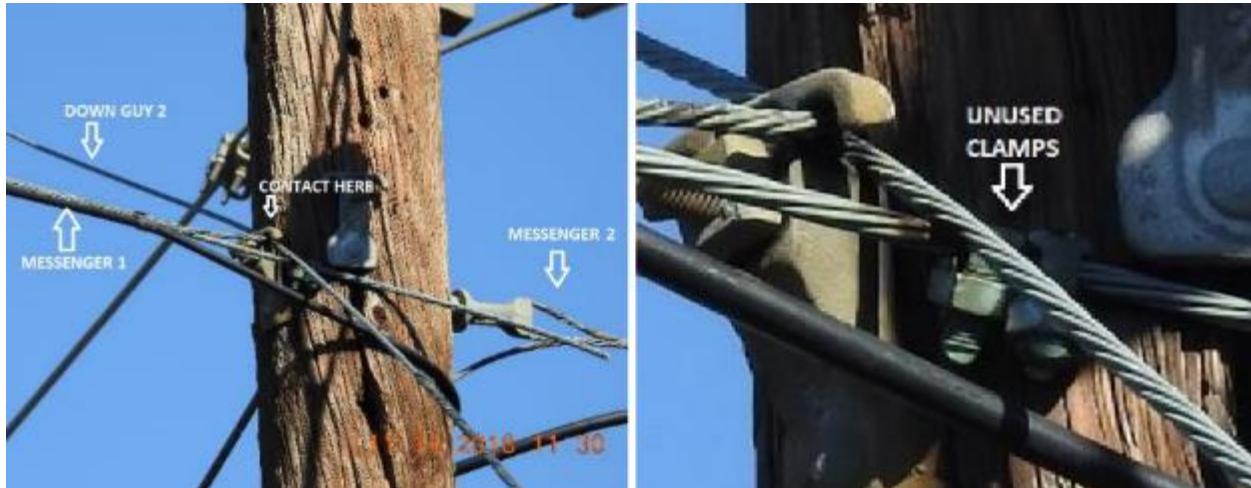
Figure 6: The top of the Stubbed Pole as viewed from the southwest. Note the unattached bonding extension on Messenger Wire 1 in the photograph on the left. On the right is a detail of the extension showing the unused bonding clamps.⁹

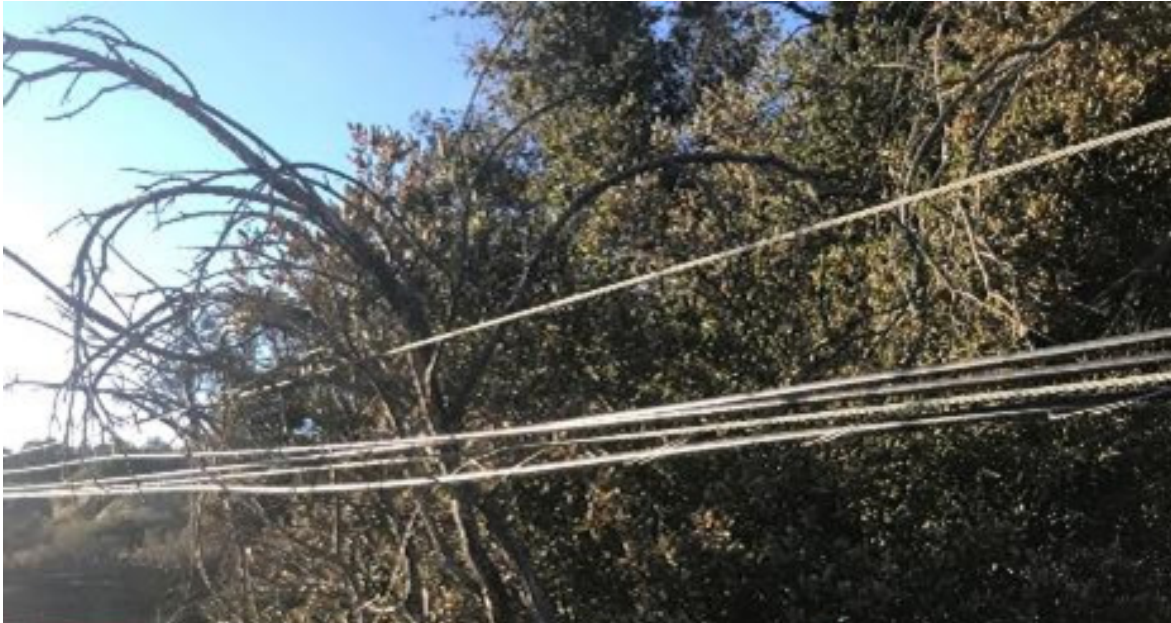
Figure 7: Overgrown tree branches pressing the ECS communications conductor into the third-party communications conductor at Site 1. The communications conductors separated from their messenger guys when their lashing wires melted during the arcing event.¹⁴

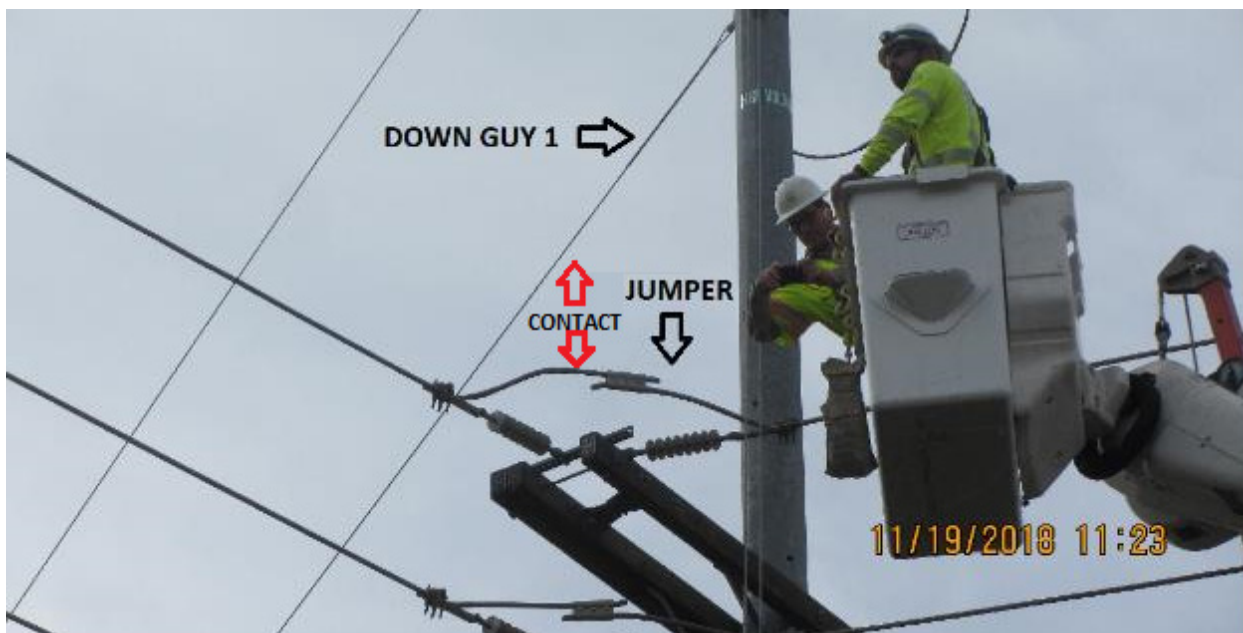
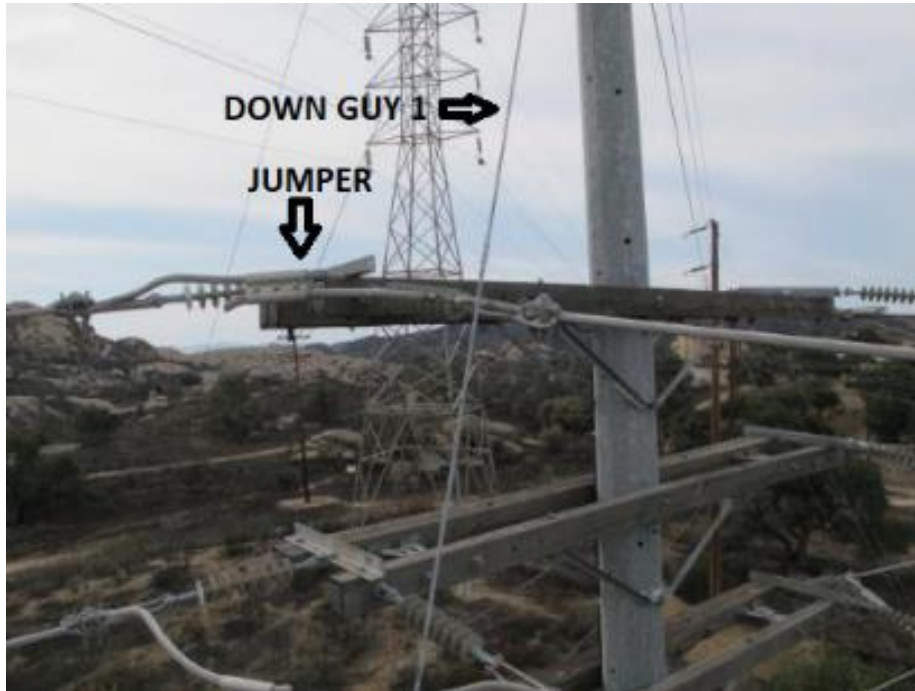
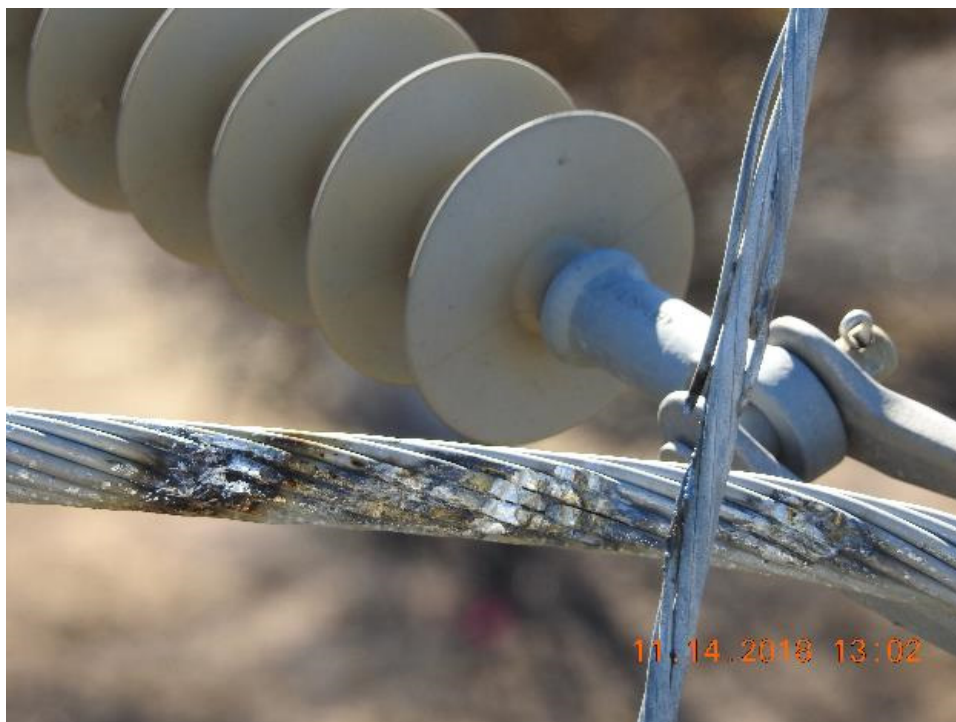
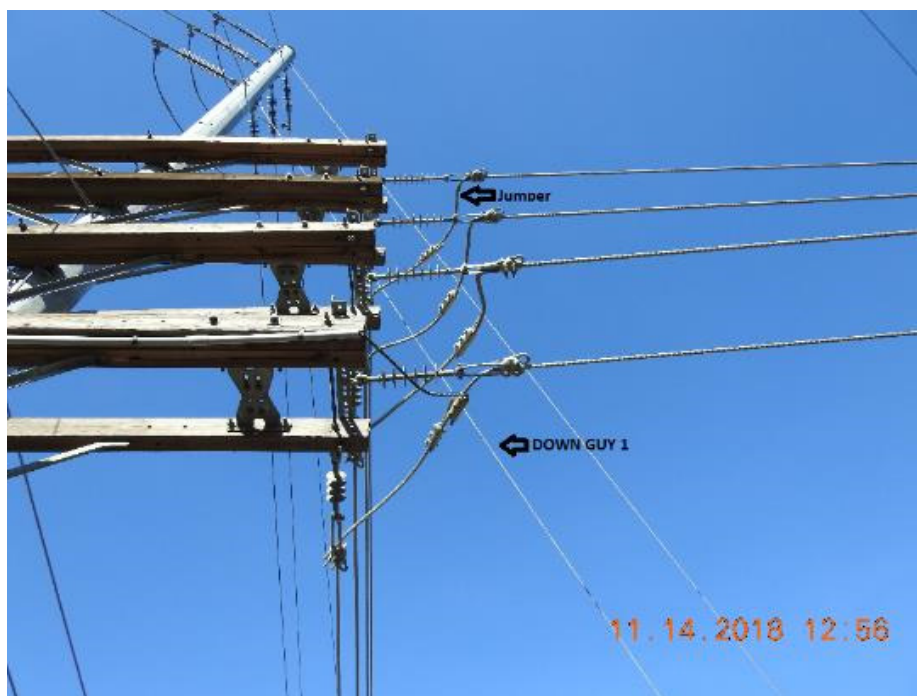
On November 14, 2018, SED Staff visited Site 2. SED Staff observed damage to an Edison transmission down guy wire (Down Guy 1), which was near an Edison 16 kV jumper wire on the east side of the Steel Pole. SED Staff rode an aerial work platform up to the height of the jumper wire and observed damage to the jumper wire and down guy consistent with arcing. Staff measured the radial clearance between the jumper wire and Down Guy 1 and found the clearance to be approximately seven inches. From measurements taken after the incident, Edison also confirmed that the clearance was approximately seven inches.²¹ See Figures 10-14.

Figure 10: Utility staff taking photographs of the down guy and jumper that made contact on the Steel Pole. Contact occurred between the red arrows.²²

Figure 11: A lateral view of Down Guy 1 and the jumper wire taken from an elevated work platform from the northeast.²³

Figure 12: The jumper wire and transmission down guy wire (Down Guy 1) on the Steel Pole. Note the burn marks on the jumper wire and the damage to the down guy wire.²⁴

Figure 13: A detail of the damage to the jumper wire on the Steel Pole and the transmission down guy wire, Down Guy 1.²⁵

Figure 14: The jumper and down guy that made contact as viewed from the base of the Steel Pole.²⁶

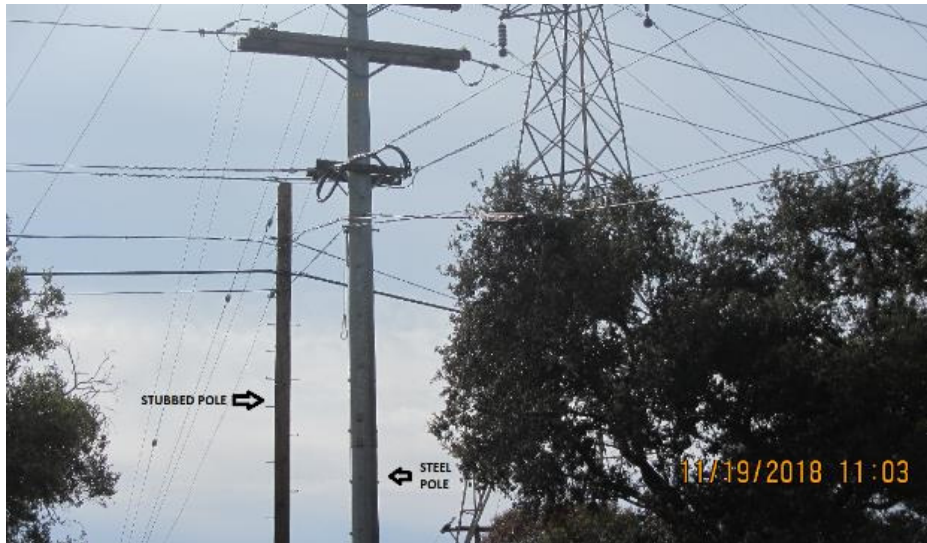
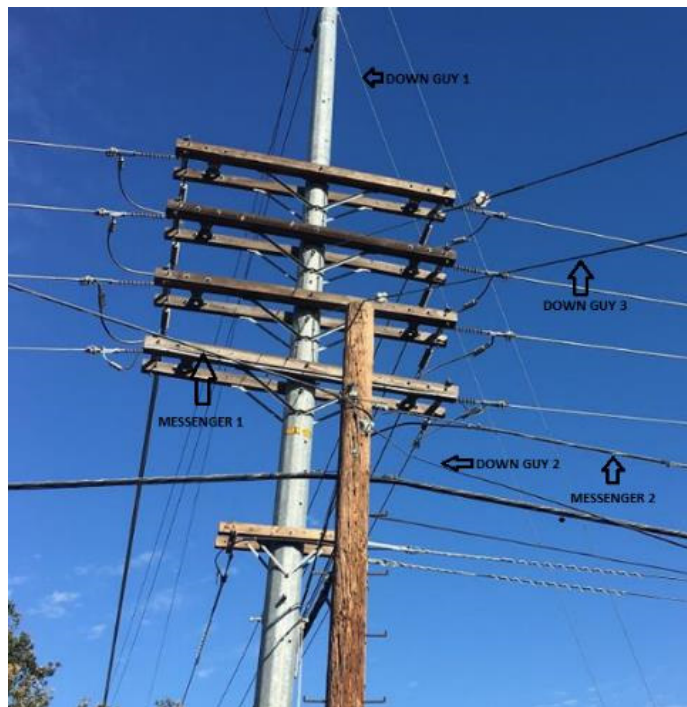
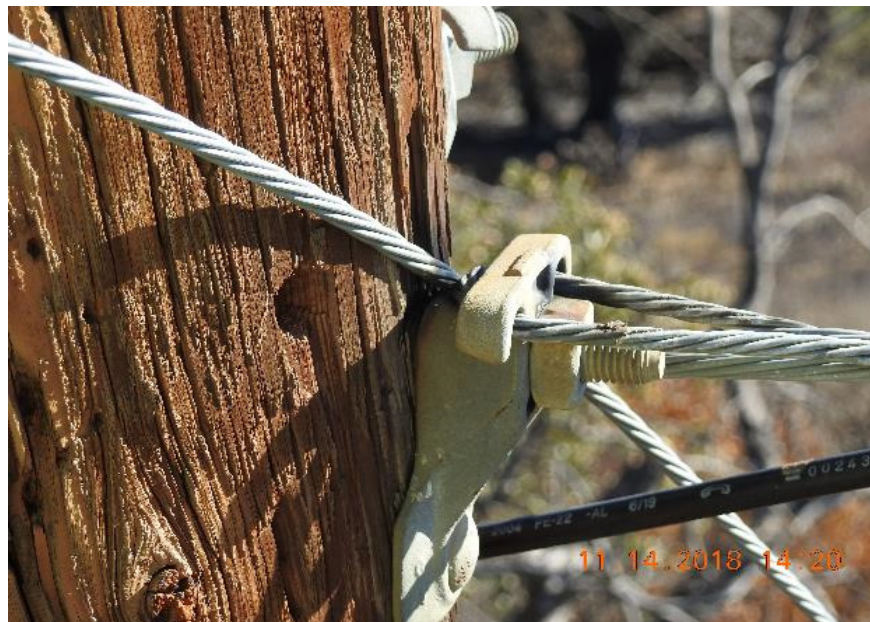
Staff observed that Down Guy 1 was loose and had sustained damage consistent with contacting the Edison 16 kV jumper wire. Staff noted that two other Edison down guy wires on the south side of the Steel Pole were also loose. The second loose down guy wire, Down Guy 2, was in contact with Messenger Wire 1 on the Stubbed Pole. The third loose down guy wire, Down Guy 3, was in contact with the top of the Stubbed Pole. Staff observed dark discoloration around the contact point between Down Guy 2 and the ECS through-bolt. See Figures 15-18.

Figure 17: A closeup of the Stubbed Pole. Note that the bonding extension on Messenger Wire 1 is not attached to anything.²⁸

Figure 18: A detail of the distribution down guy, Down Guy 2, in contact with Messenger Wire 1 and the through bolt on the Stubbed Pole. Note the blackened area on the down guy and the Stubbed Pole at the point of contact.²⁹

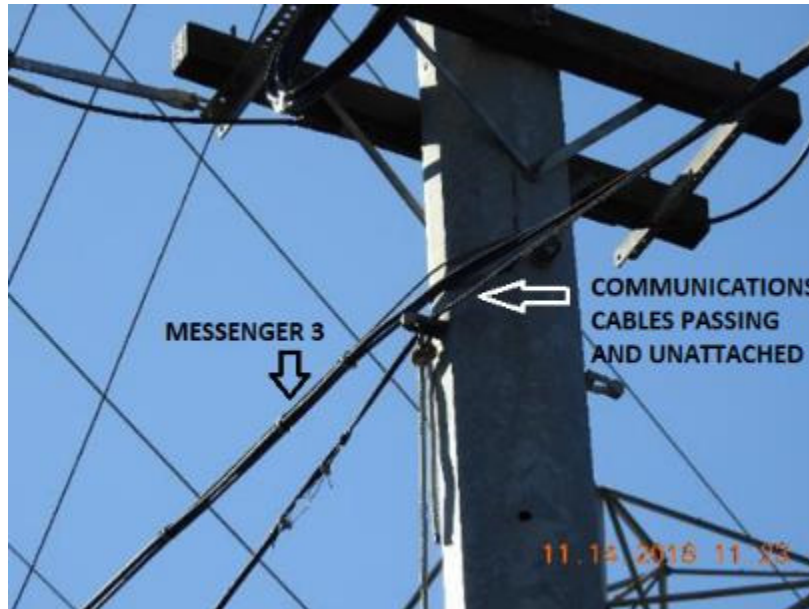
Staff observed that the two ECS communications conductors attached to the Stubby Pole traveled north past the Steel Pole towards Chatsworth substation. The two northbound ECS communications conductors were in contact with the surface of the Steel Pole but not attached to it. See Figure 19.

Figure 19: Communications conductors in contact with the surface of the steel pole, but not attached to it. Viewed from the northeast.³⁰

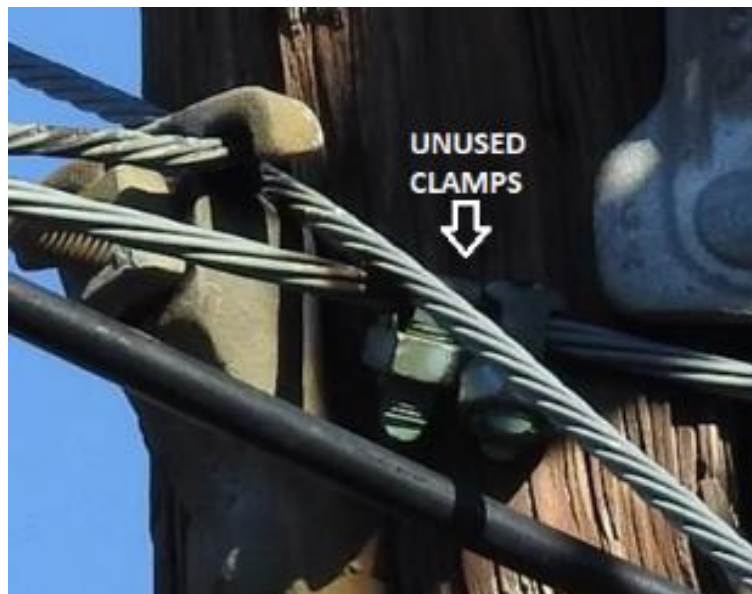
Messenger Wire 3 was not bonded to the two other ECS messenger wires (Messenger Wires 1 and 2) that were attached to the through-bolt on the Stubbed Pole, although all three messenger wires had bonding wires and the bonding brackets were present on Messenger Wire 1. Bonding wires are short extensions on the end of messenger guys. They are designed to be connected together with brackets as part of a grounding scheme. See Figure 21.

Figure 21: A detail of Messenger Wire 1 and Down Guy 2 showing the unused bonding clamps.³²

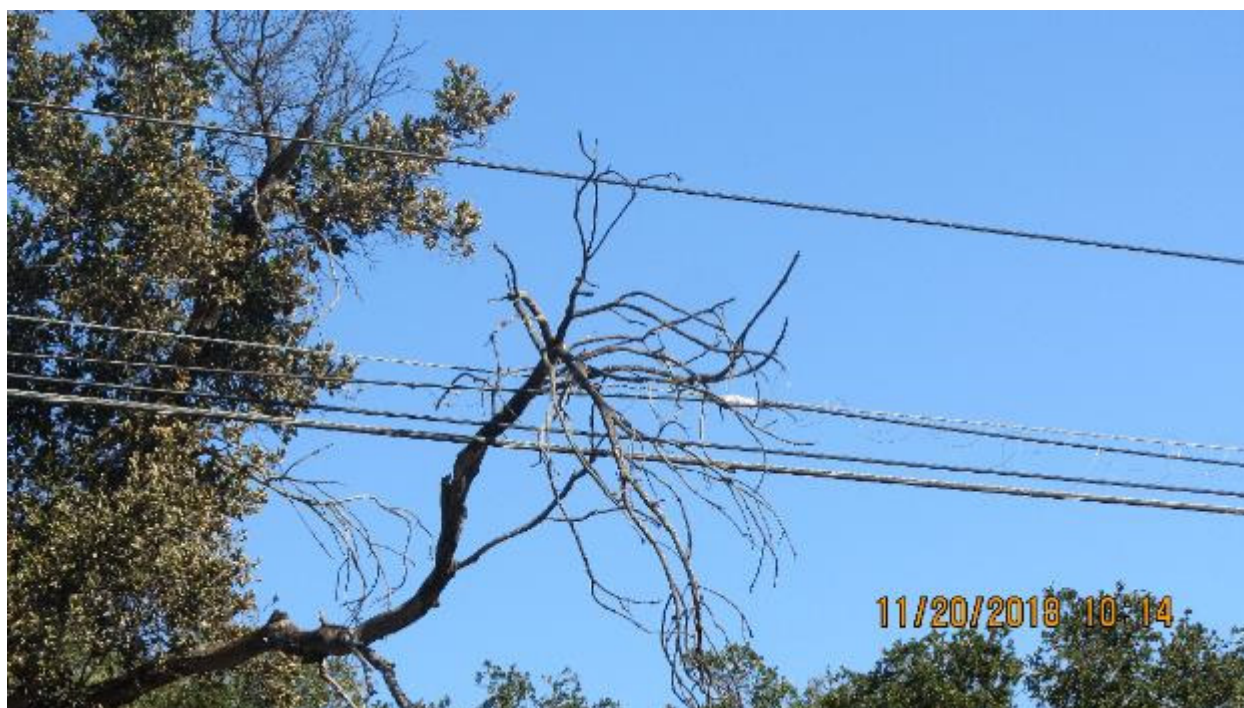
Figure 24: One of the branches pressing the communications conductors together at Site 1.³⁵

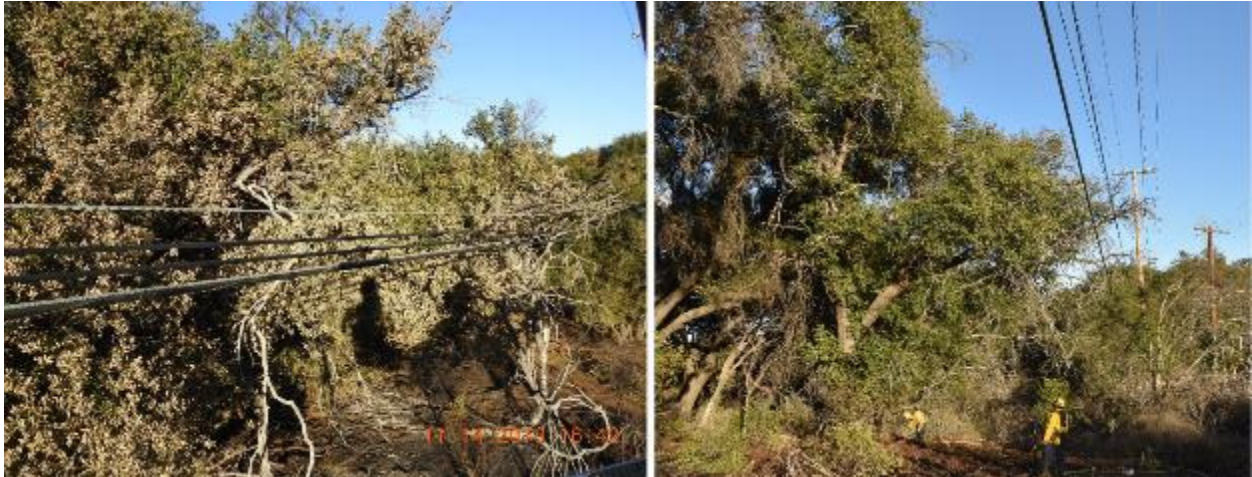
Figure 26: On the left are the communications conductors and tree branches as they appeared on November 14, 2018. On the right is a photograph taken by VCFD of the same part of the span in December 2015.³⁹

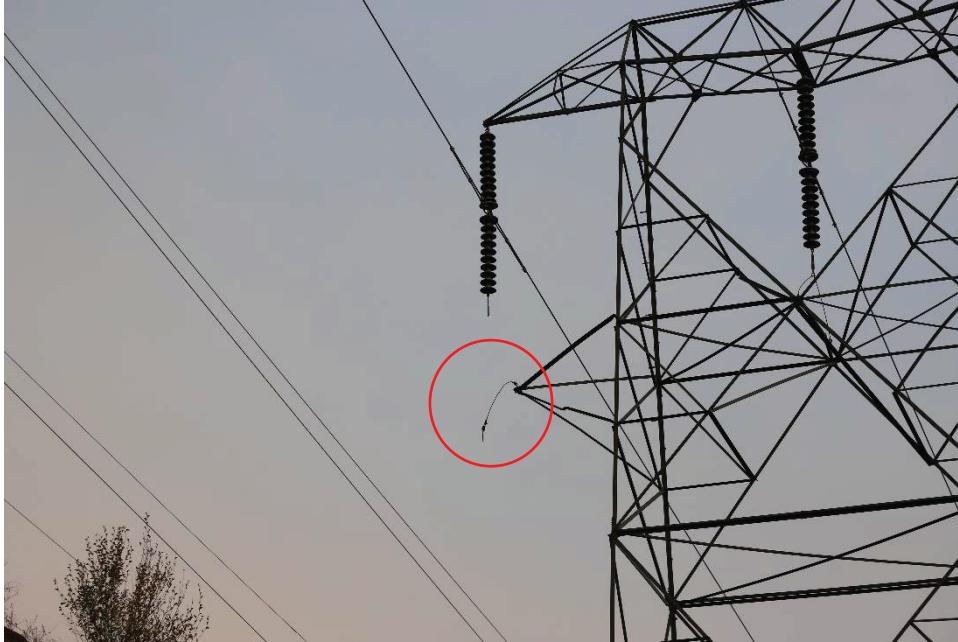
Figure 2. At Tower :27/221, an insulator hold-down anchor was disconnected. Photo provided by PG&E.⁷⁸

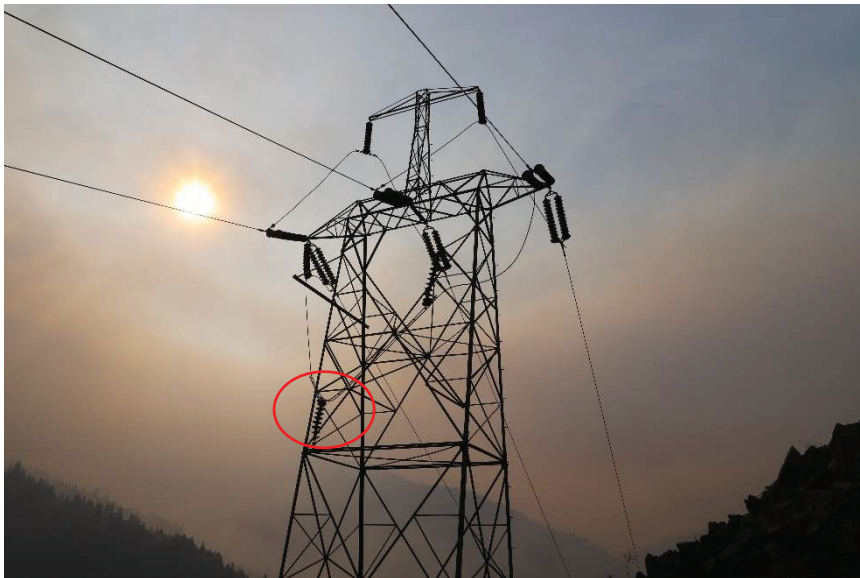
Figure 3. At the Incident Tower, an insulator detached from the hanger plate and hung upside down. Photo provided by PG&E.⁷⁹

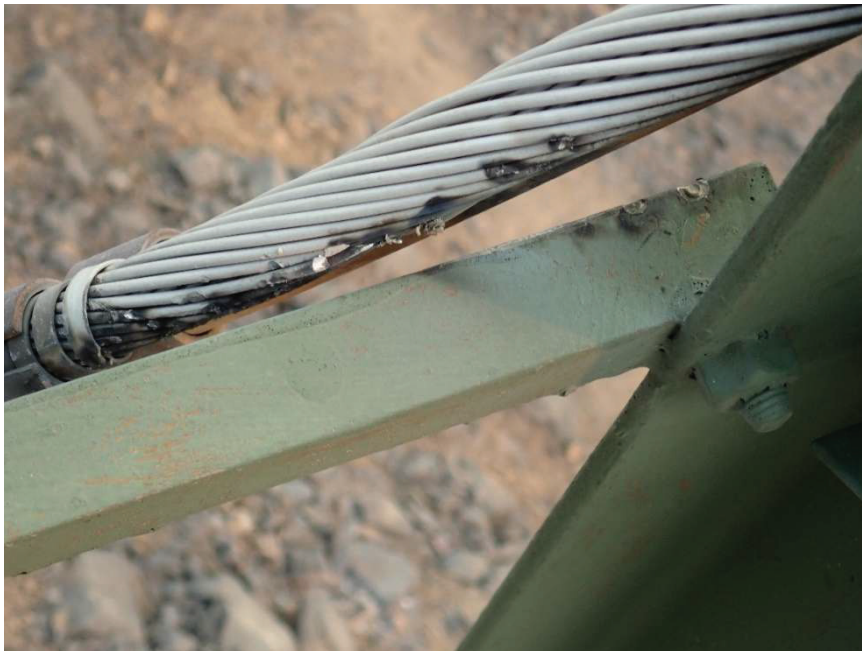
Figure 5. Flash marks on the transposition jumper and steel member on the Incident Tower. Photo provided by PG&E.⁸¹

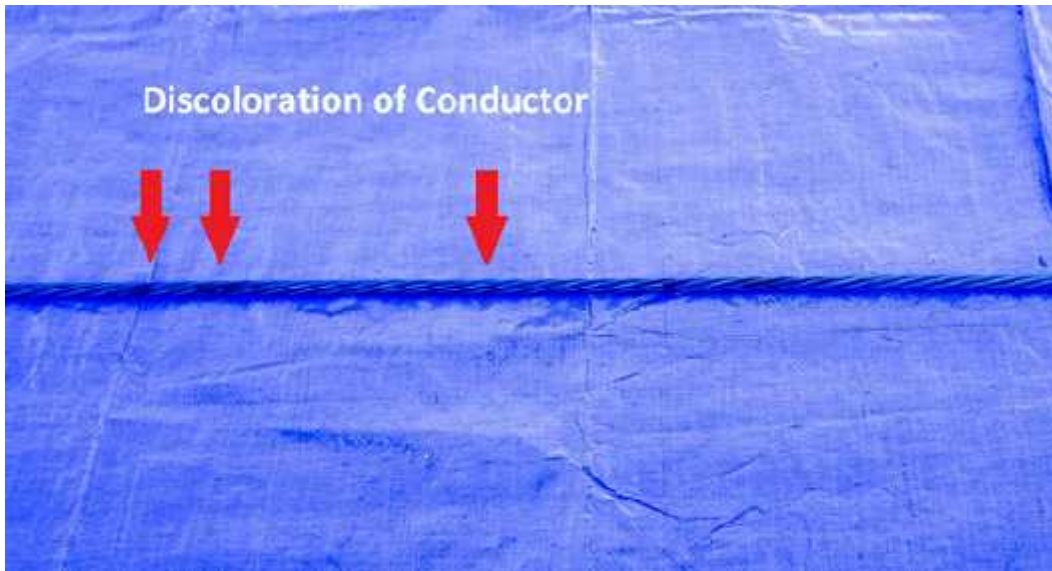
Figure 4 – Discoloration on Conductor (Enhanced)

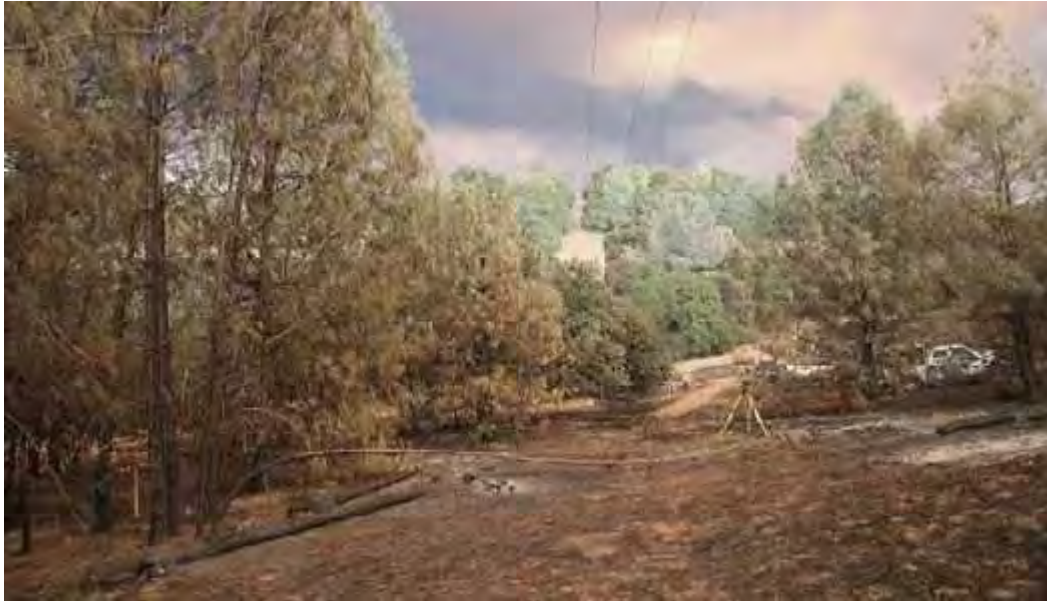
Figure 6 -
The pine tree lying on the ground after contacting the 12 kV conductor

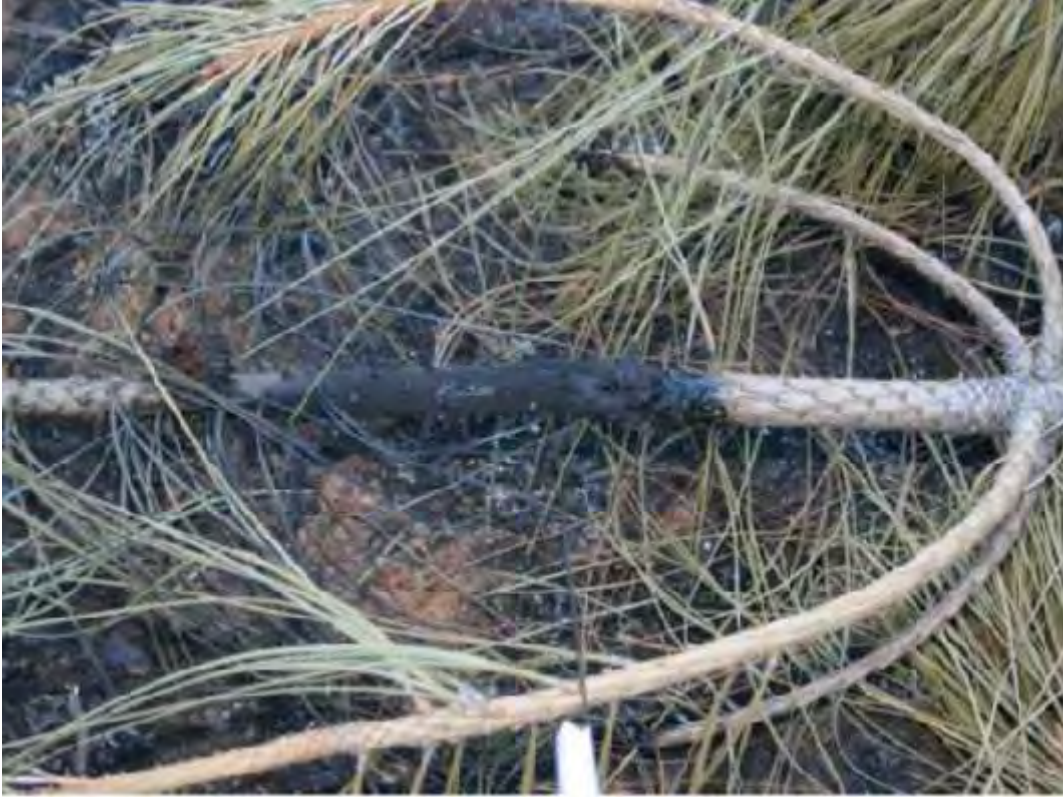
Figure 7 –
Burn marks on the pine tree which indicates contact
